Repairs to heating cables

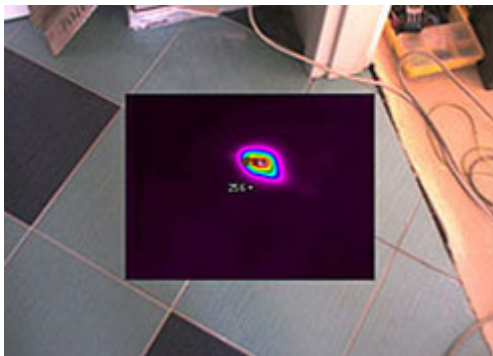
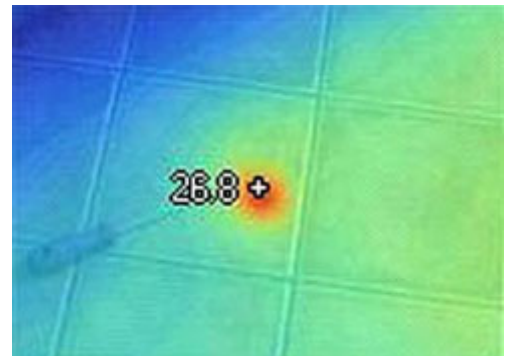
The place of interruption can be located in two ways – firstly, a high-frequency signal can be released into the cable with the help of which the interruption can be located, while the second option is the use of an infra-camera. Both ends of the interrupted heating cable are less than a millimetre apart from each other in the floor – the cement, concrete or anhydride doesn't allow the cable to move apart. The heating cable is connected to high voltage and therefore an electric arc will have been created between both ends. This has a temperature many times higher than the temperature of the heating cable, and thus it is possible to find the place of breakdown perfectly accurately with the help of an infra-camera. Tests show that if the concrete is 10 cm thick, it takes less than 10 minutes for the warm spot to show up on the floor surface.

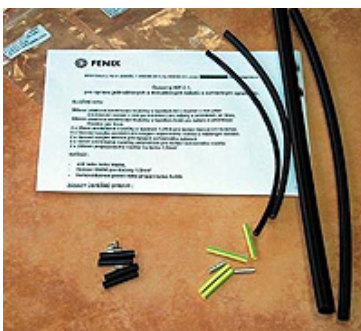
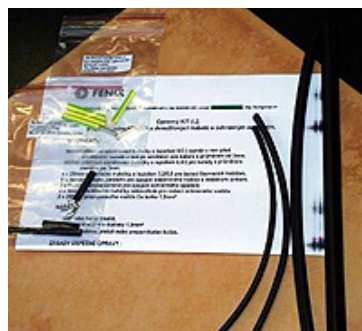
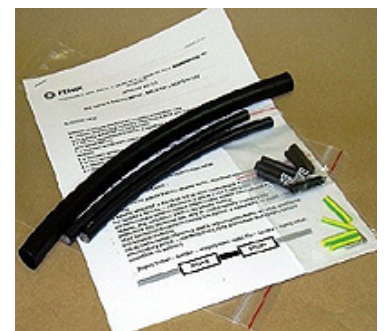
What are known as repair kits are used for repairs. These are kits which contain pressing connectors, connecting conductors and compression insulation. There are several kits depending on the types of cables they are intended for.
